Test Report No.: CKGEC25000977503 **Date**: Jul 17, 2025 Page 1 of 4

Sample Name: Paper Corner

Halogen

Test Method: With reference to EN 14582:2016, analysis was performed by IC.

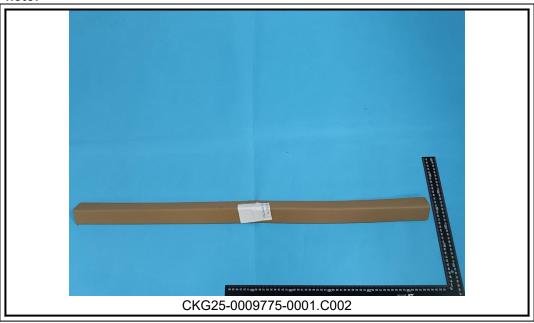
Sample Photo:

Ī	SN ID	Sample No.	SGS Sample ID	Description
	SN1	A2	CKG25-0009775-0001.C002	Brown paper corner protector
